# MEP Site Visit Report

## Riverside House – MEP Fit-Out

Visit 02 / 21/07/2026

| WR-2026-014 | J. Nolan | Final | 21/07/2026 |

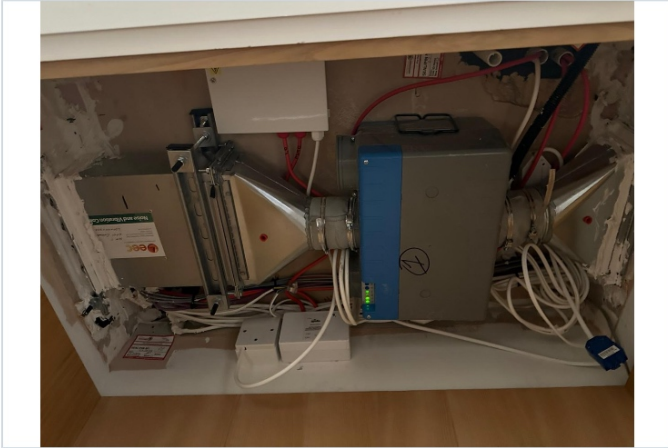
SITE PHOTOGRAPH AP04

Raised following the partial AHU-01 interface demonstration recorded in the witnessing section.

| LOCATION | TEST UNDERTAKEN | DESIGN |
|---|---|---|
| M. Reed – Controls Logic Ltd | Draft BMS points schedule Rev P03 | Dirty-filter alarm could not be safely simulated during the visit. |
| Run and common-fault status were demonstrated successfully. Provide a witnessed record for the remaining dirty-filter alarm before handover. | | |

Demonstrate the AHU-01 dirty-filter alarm and provide the final BMS points schedule, alarm matrix and trend records for inclusion in the handover information.
